# Soapstone Valley Park Sewer Rehabilitation Project

## Shots #1-9

<b>Client:</b>	<b>DC Water / WRF</b>
<b>Location:</b>	<b>Soapstone Valley Park, Washington, DC</b>
<b>Date:</b>	<b>3/14/2023</b>
<b>Summary:</b>	Air monitoring performed during <b>shot #1 M-10445 to M-10343</b> . Air monitoring results were less than the Action Levels.

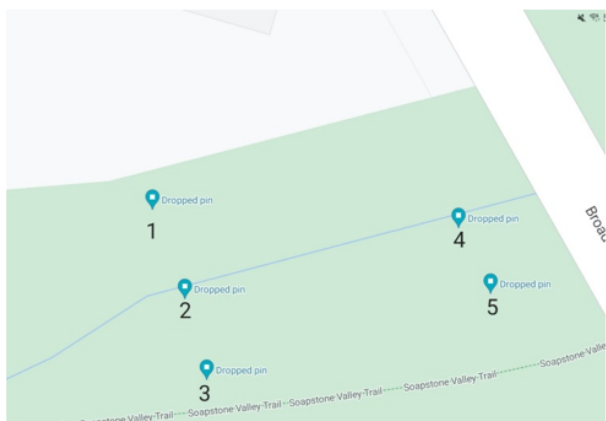
**Site Map**

Shot 1: M10445 to M10343		
ID	Location (Latitude - Longitude)	Canister Position
1	(38.9454416, -77.0514673)	Upwind
2	(38.9453756, -77.0514365)	4" above insertion manhole
3	(38.9453159, -77.0514157)	Downwind
4	(38.9454280, -77.0511760)	4" above terminal manhole
5	(38.9453795, -77.0511455)	Near terminal manhole

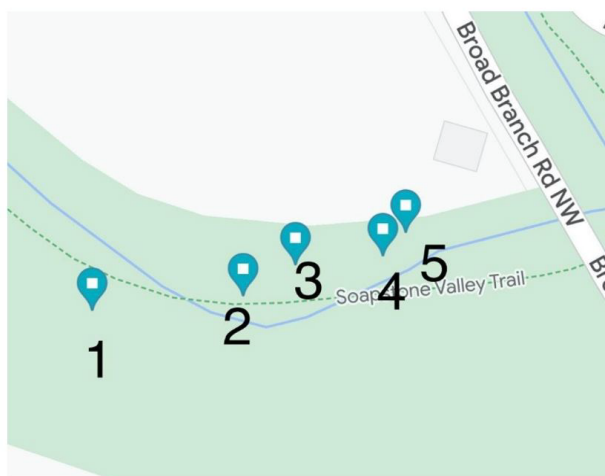
Site Map

Shot 2: M10445 to M10363		
ID	Location (Latitude - Longitude)	Canister Position
1	(38.9452356, -77.0525375)	Downwind
2	(38.9452718, -77.0520725)	4" above insertion manhole
3	(38.9453469, -77.0519116)	Upwind
4	(38.9453683, -77.0516427)	4" above terminal manhole
5	(38.9454262, -77.0515736)	Near terminal manhole

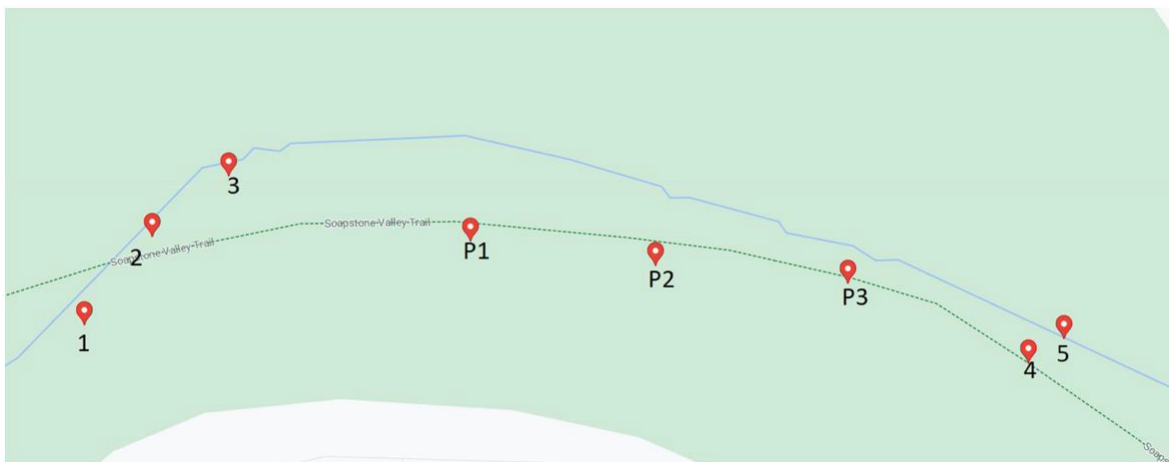
## Site Map

Shot 4: M10443 to M10364		
ID	Location (Latitude – Longitude)	Canister Position
1	(38.9463899, -77.0559812)	Upwind
2	(38.9465206, -77.0558527)	4" above insertion manhole
3	(38.9466092, -77.0557072)	Downwind
4	(38.946513, -77.055249)	Passthrough manhole 1
5	(38.946477, -77.054898)	Passthrough manhole 2
6	(38.946451, -77.054533)	Passthrough manhole 3
7	(38.9463339, -77.0541908)	4" above terminal manhole
8	(38.9463693, -77.0541237)	Near terminal manhole

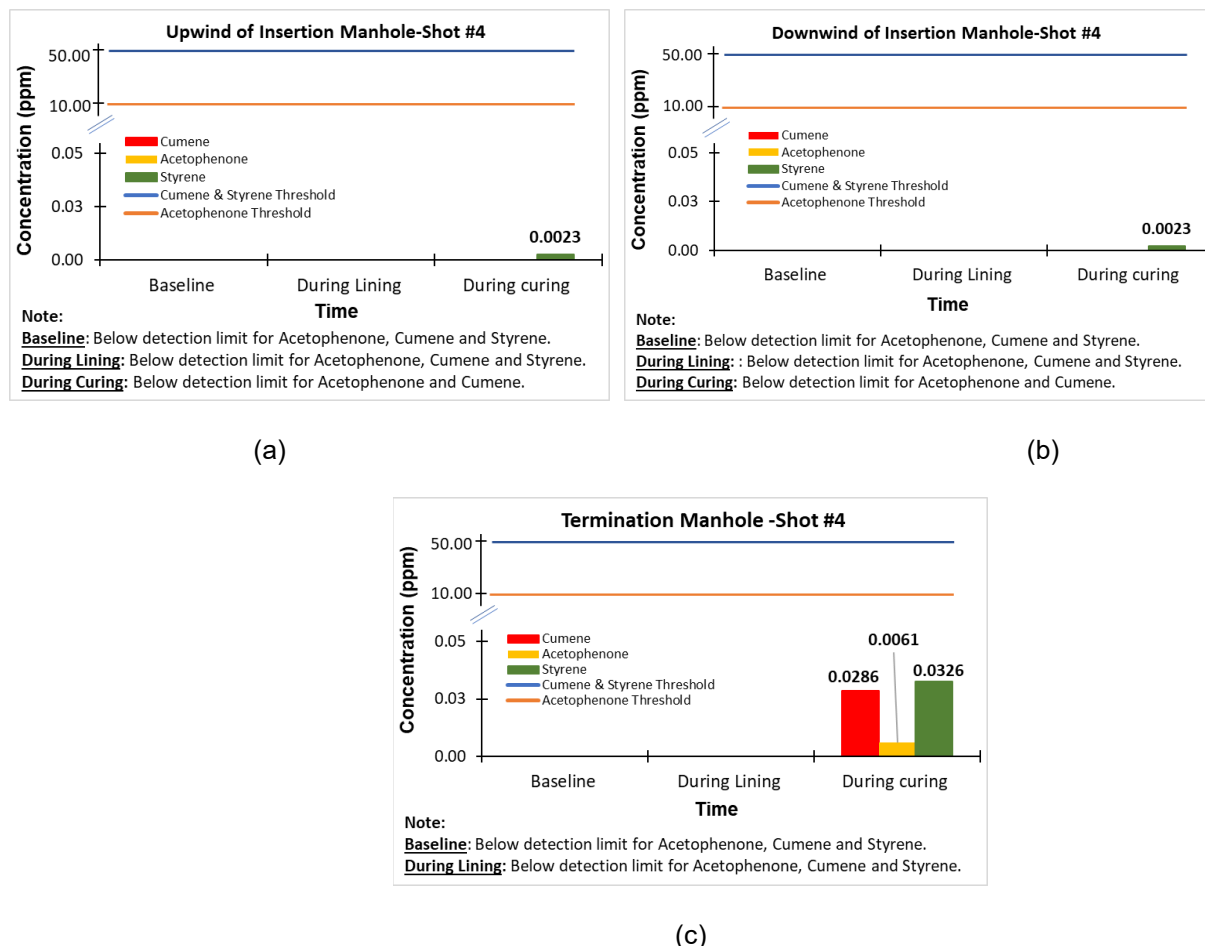
Figure 5. Summa Canister Analysis (a) Upwind Insertion MH, (b) Downwind Insertion MH, and (c) Termination MH

Based on figure 4 Cumene and acetophenone concentrations were below the detection limit for the upwind and downwind of insertion manhole for the baseline, during lining and curing activities. Cumene and acetophenone concentrations were also below the detection limit for the baseline and during lining at the termination manhole. However, during the curing activity, cumene and acetophenone concentrations were 0.0286 ppm and 0.061 ppm, respectively at the termination manhole which was significantly low below the threshold limit of 50 ppm and 10 ppm. Styrene concentration was 0.0023 ppm at the upwind and downwind of insertion manhole, and 0.033 ppm during curing activity at the termination manhole which was significantly below the threshold limit of 50 ppm.

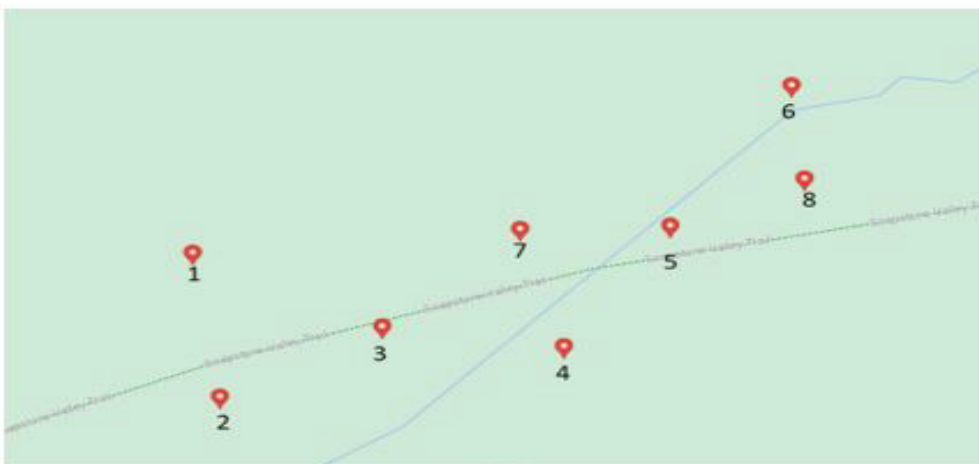
**Site Map**

Shot 5: M10409 to M10443		
ID	Location (Latitude – Longitude)	Canister Position
1	(38.9464974, -77.0562988)	Lateral manhole
2	(38.9463663, -77.0562721)	4" above terminal manhole
3	(38.9464272, -77.0561294)	Passthrough manhole
4	(38.9464132, -77.0559651)	Upwind
5	(38.9465175, -77.0558671)	4" above insertion manhole
6	(38.9466439, -77.0557578)	Downwind
7	(38.9465049, -77.0560023)	New Upwind
8	(38.9465495, -77.0557465)	New Downwind

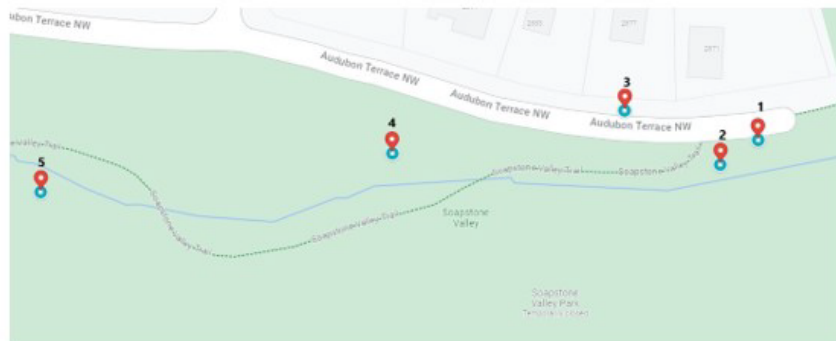
**Site Map**

Shot 6: M10412 to M10442		
ID	Location (Latitude - Longitude)	Canister Position
1	(38.946134, -77.057102)	Downwind
2	(38.946060, -77.057246)	4" above insertion manhole
3	(38.946221, -77.057612)	Upwind
4	(38.946093, -77.058498)	Passthrough Manhole 1
5	(38.945979, -77.059837)	4" above terminal manhole

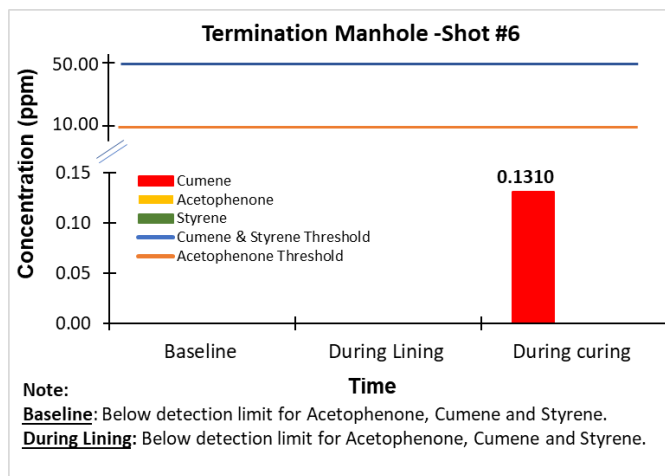
**Figure 12.** Summa Canister Analysis (a) Upwind Insertion MH, (b) Downwind Insertion MH, and (c) Termination MH

Based on the Figure 12, cumene and acetophenone concentrations are below the detection limit of the instrument at the insertion (upwind & downwind) and terminal manhole for the baseline, during lining, and curing activities; hence, it is not displayed on the graphs. Styrene concentrations for upwind and downwind of insertion manhole and termination manhole during baseline and lining were not detected, but it was 0.0065 ppm at the upwind and downwind of insertion manhole during curing, at the termination manhole the cumene concentration was 0.1310 for during curing which were significantly below the threshold limits.

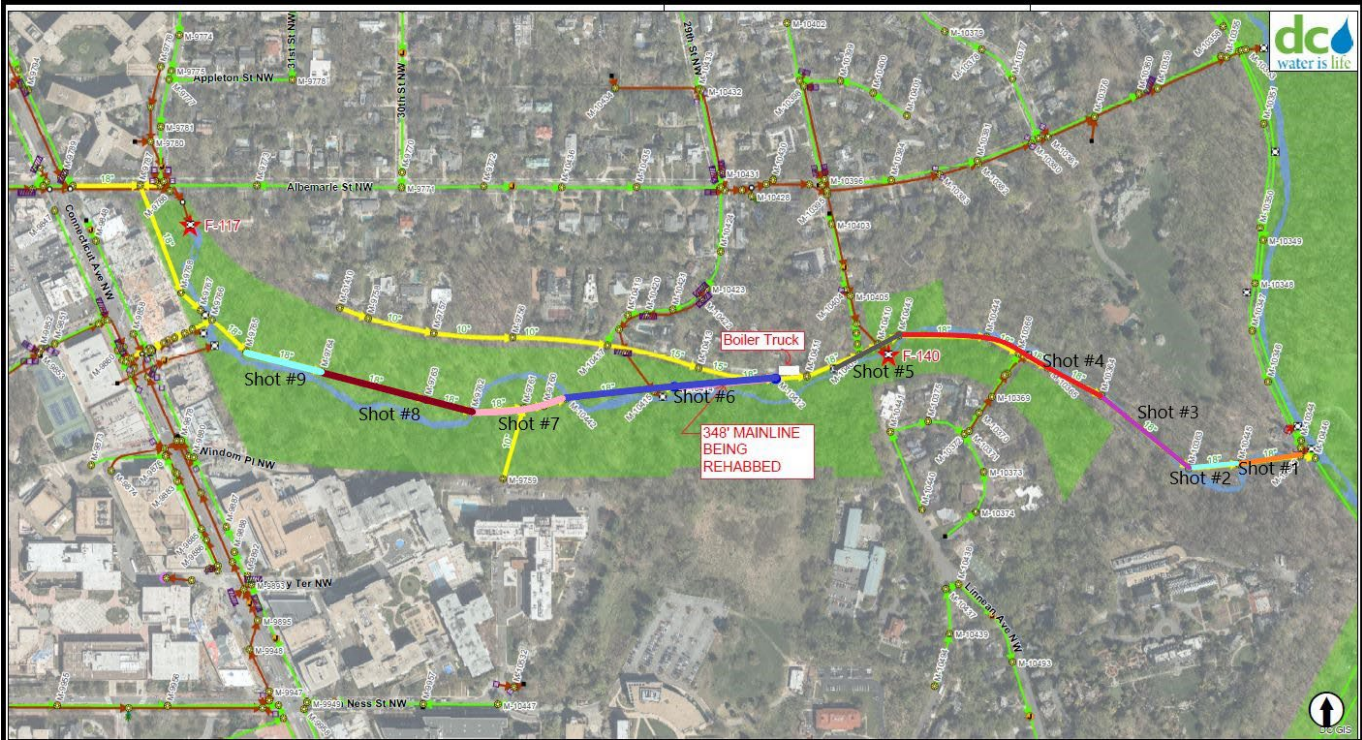
Figure 19. Summary map showing Shots completed (1 - 9)
